**Appendix I. Kings Beach Commercial
Core Improvement Project
Preliminary Delineation of
Wetlands and Other Waters of
the United States and USACE
Verification Letter**

Preliminary Delineation of Wetlands and Other Waters of the United States

Placer County, California
03-PLA-28 KP 14.79/16.53 (PM 9.19/10.27)
EA 03-198-0C9300

November 2006

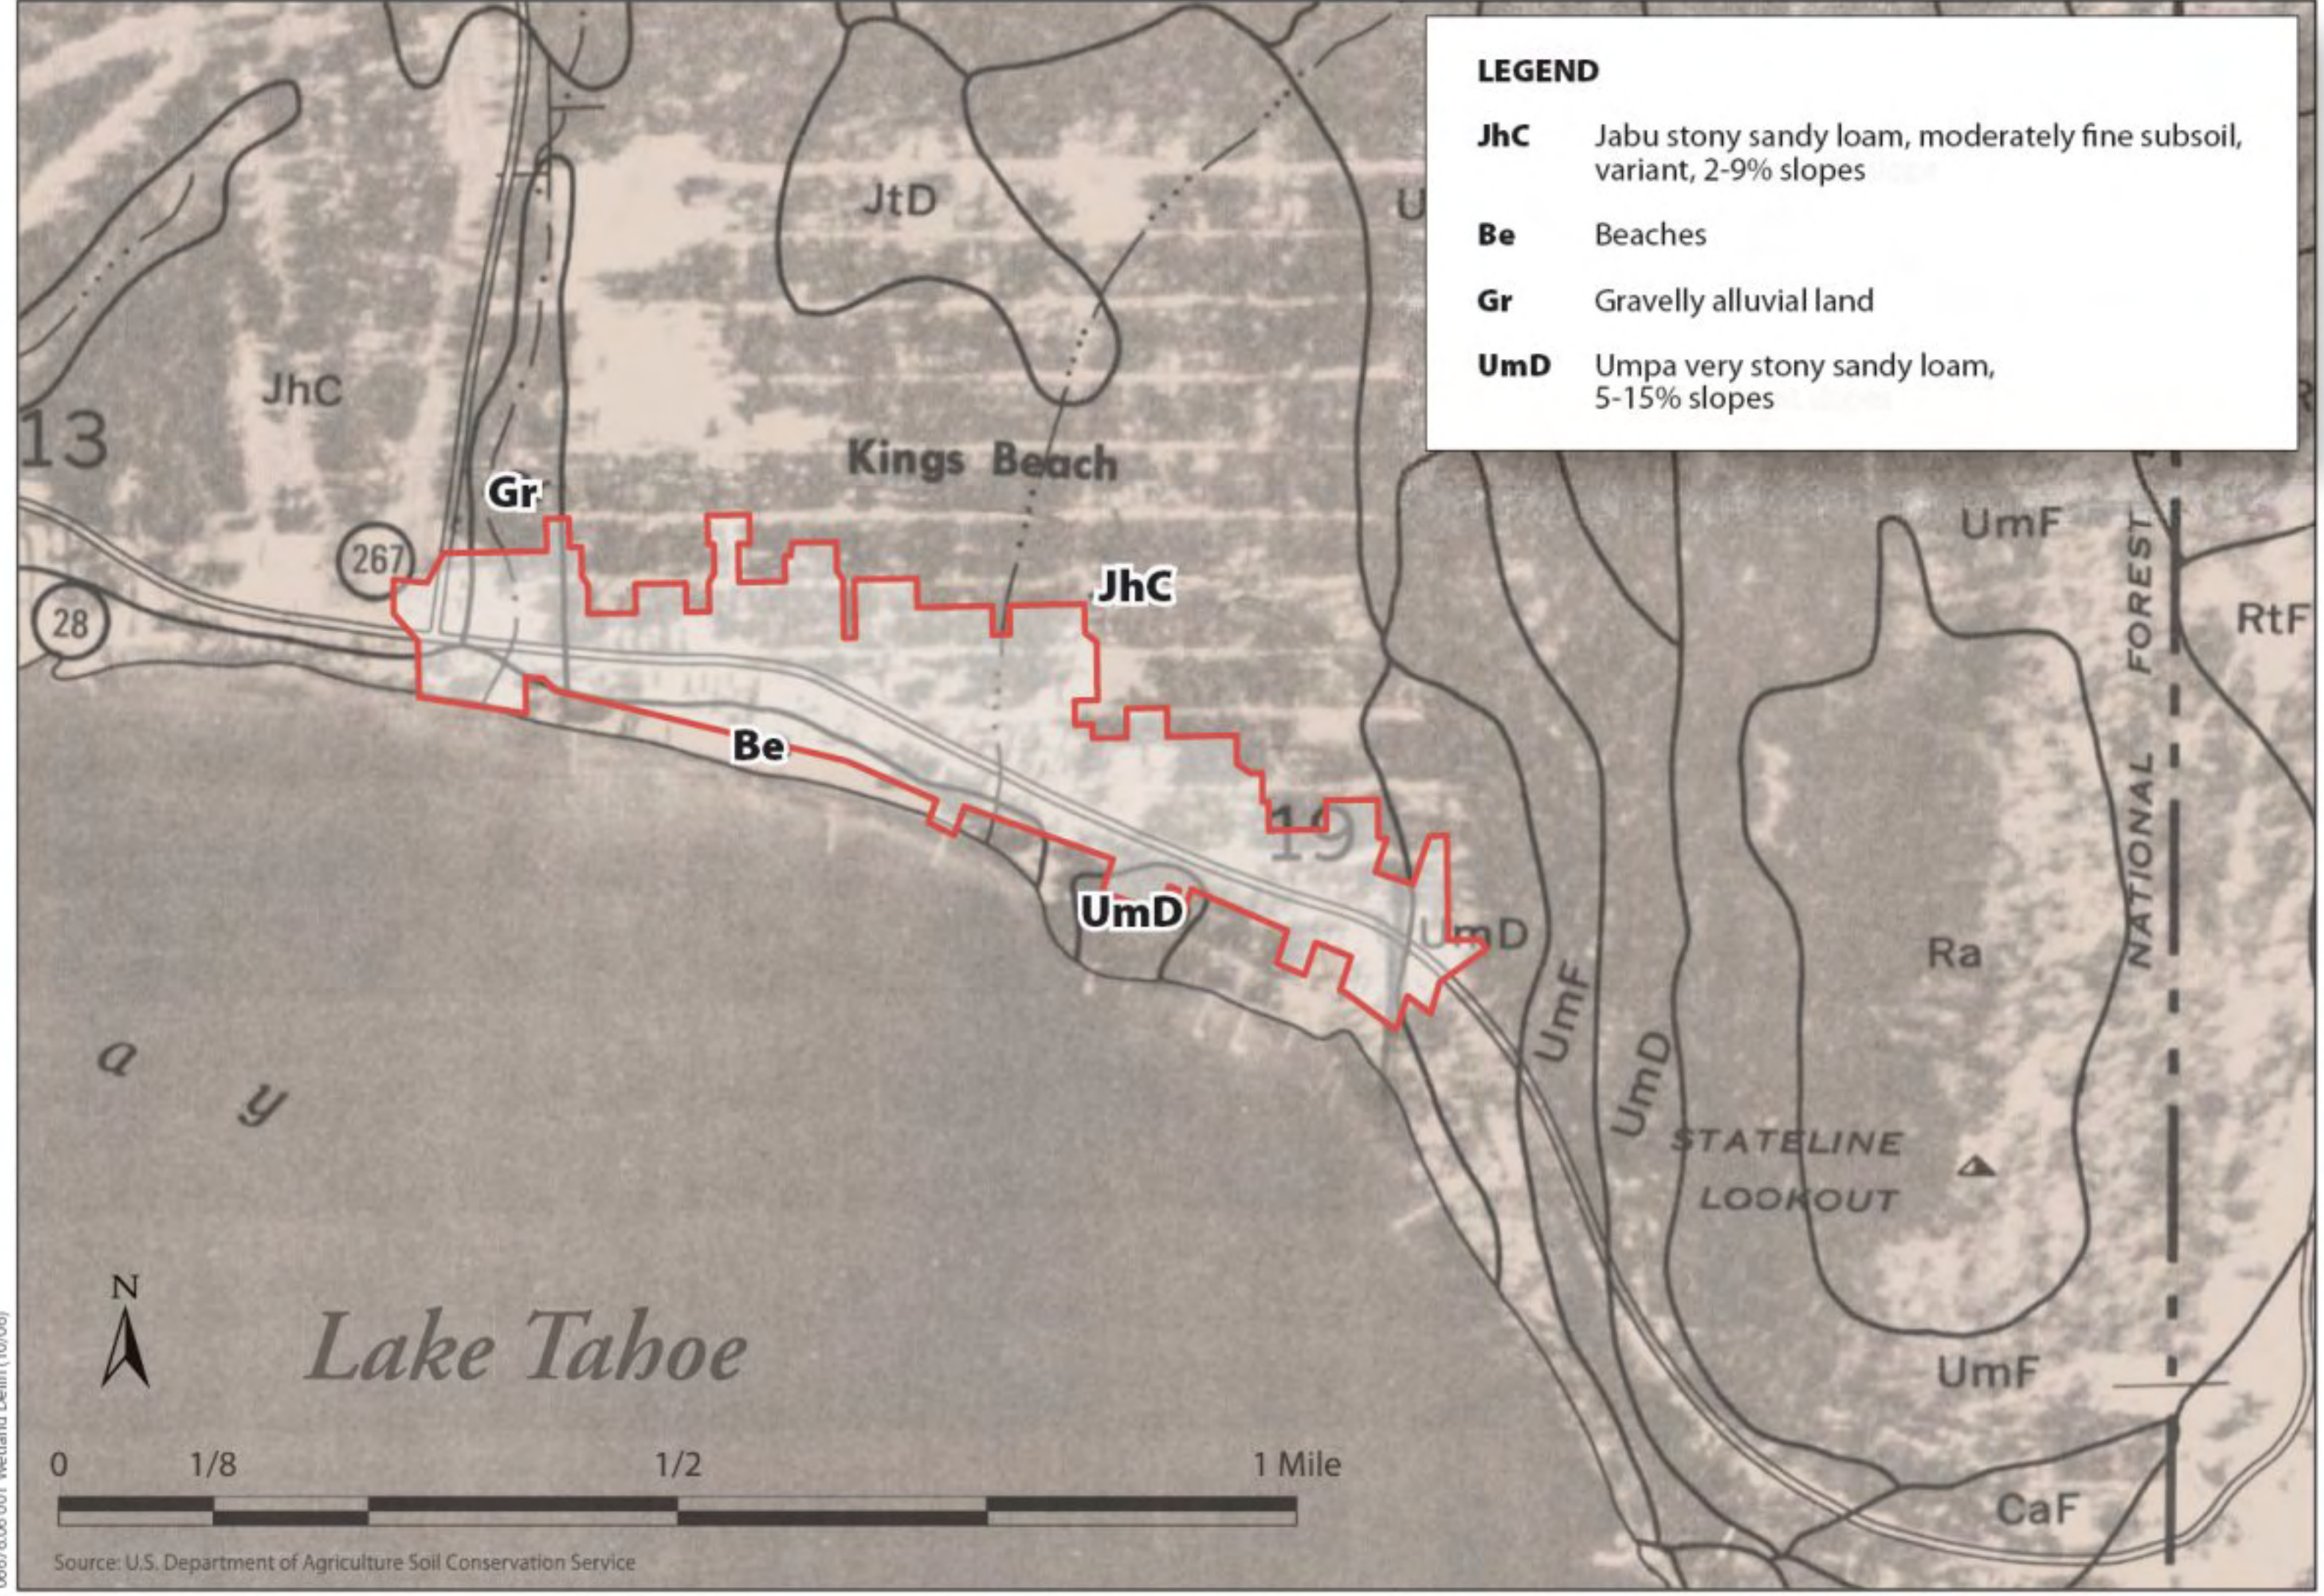
Figure 2
Soils Survey Map

Soils in the delineation study area were mapped by the U.S. Soil Conservation Service during their survey of soils in the Lake Tahoe Basin (Rogers 1974). A total of four soil map units occur within the boundaries of the delineation study area (Figure 2). The general characteristics of the soils that occur within these map units are summarized in Table 2. Of the four soil map units that occur within the delineation study area, only the Beaches map unit is known to contain hydric inclusions (Natural Resources Conservation Service 1992).

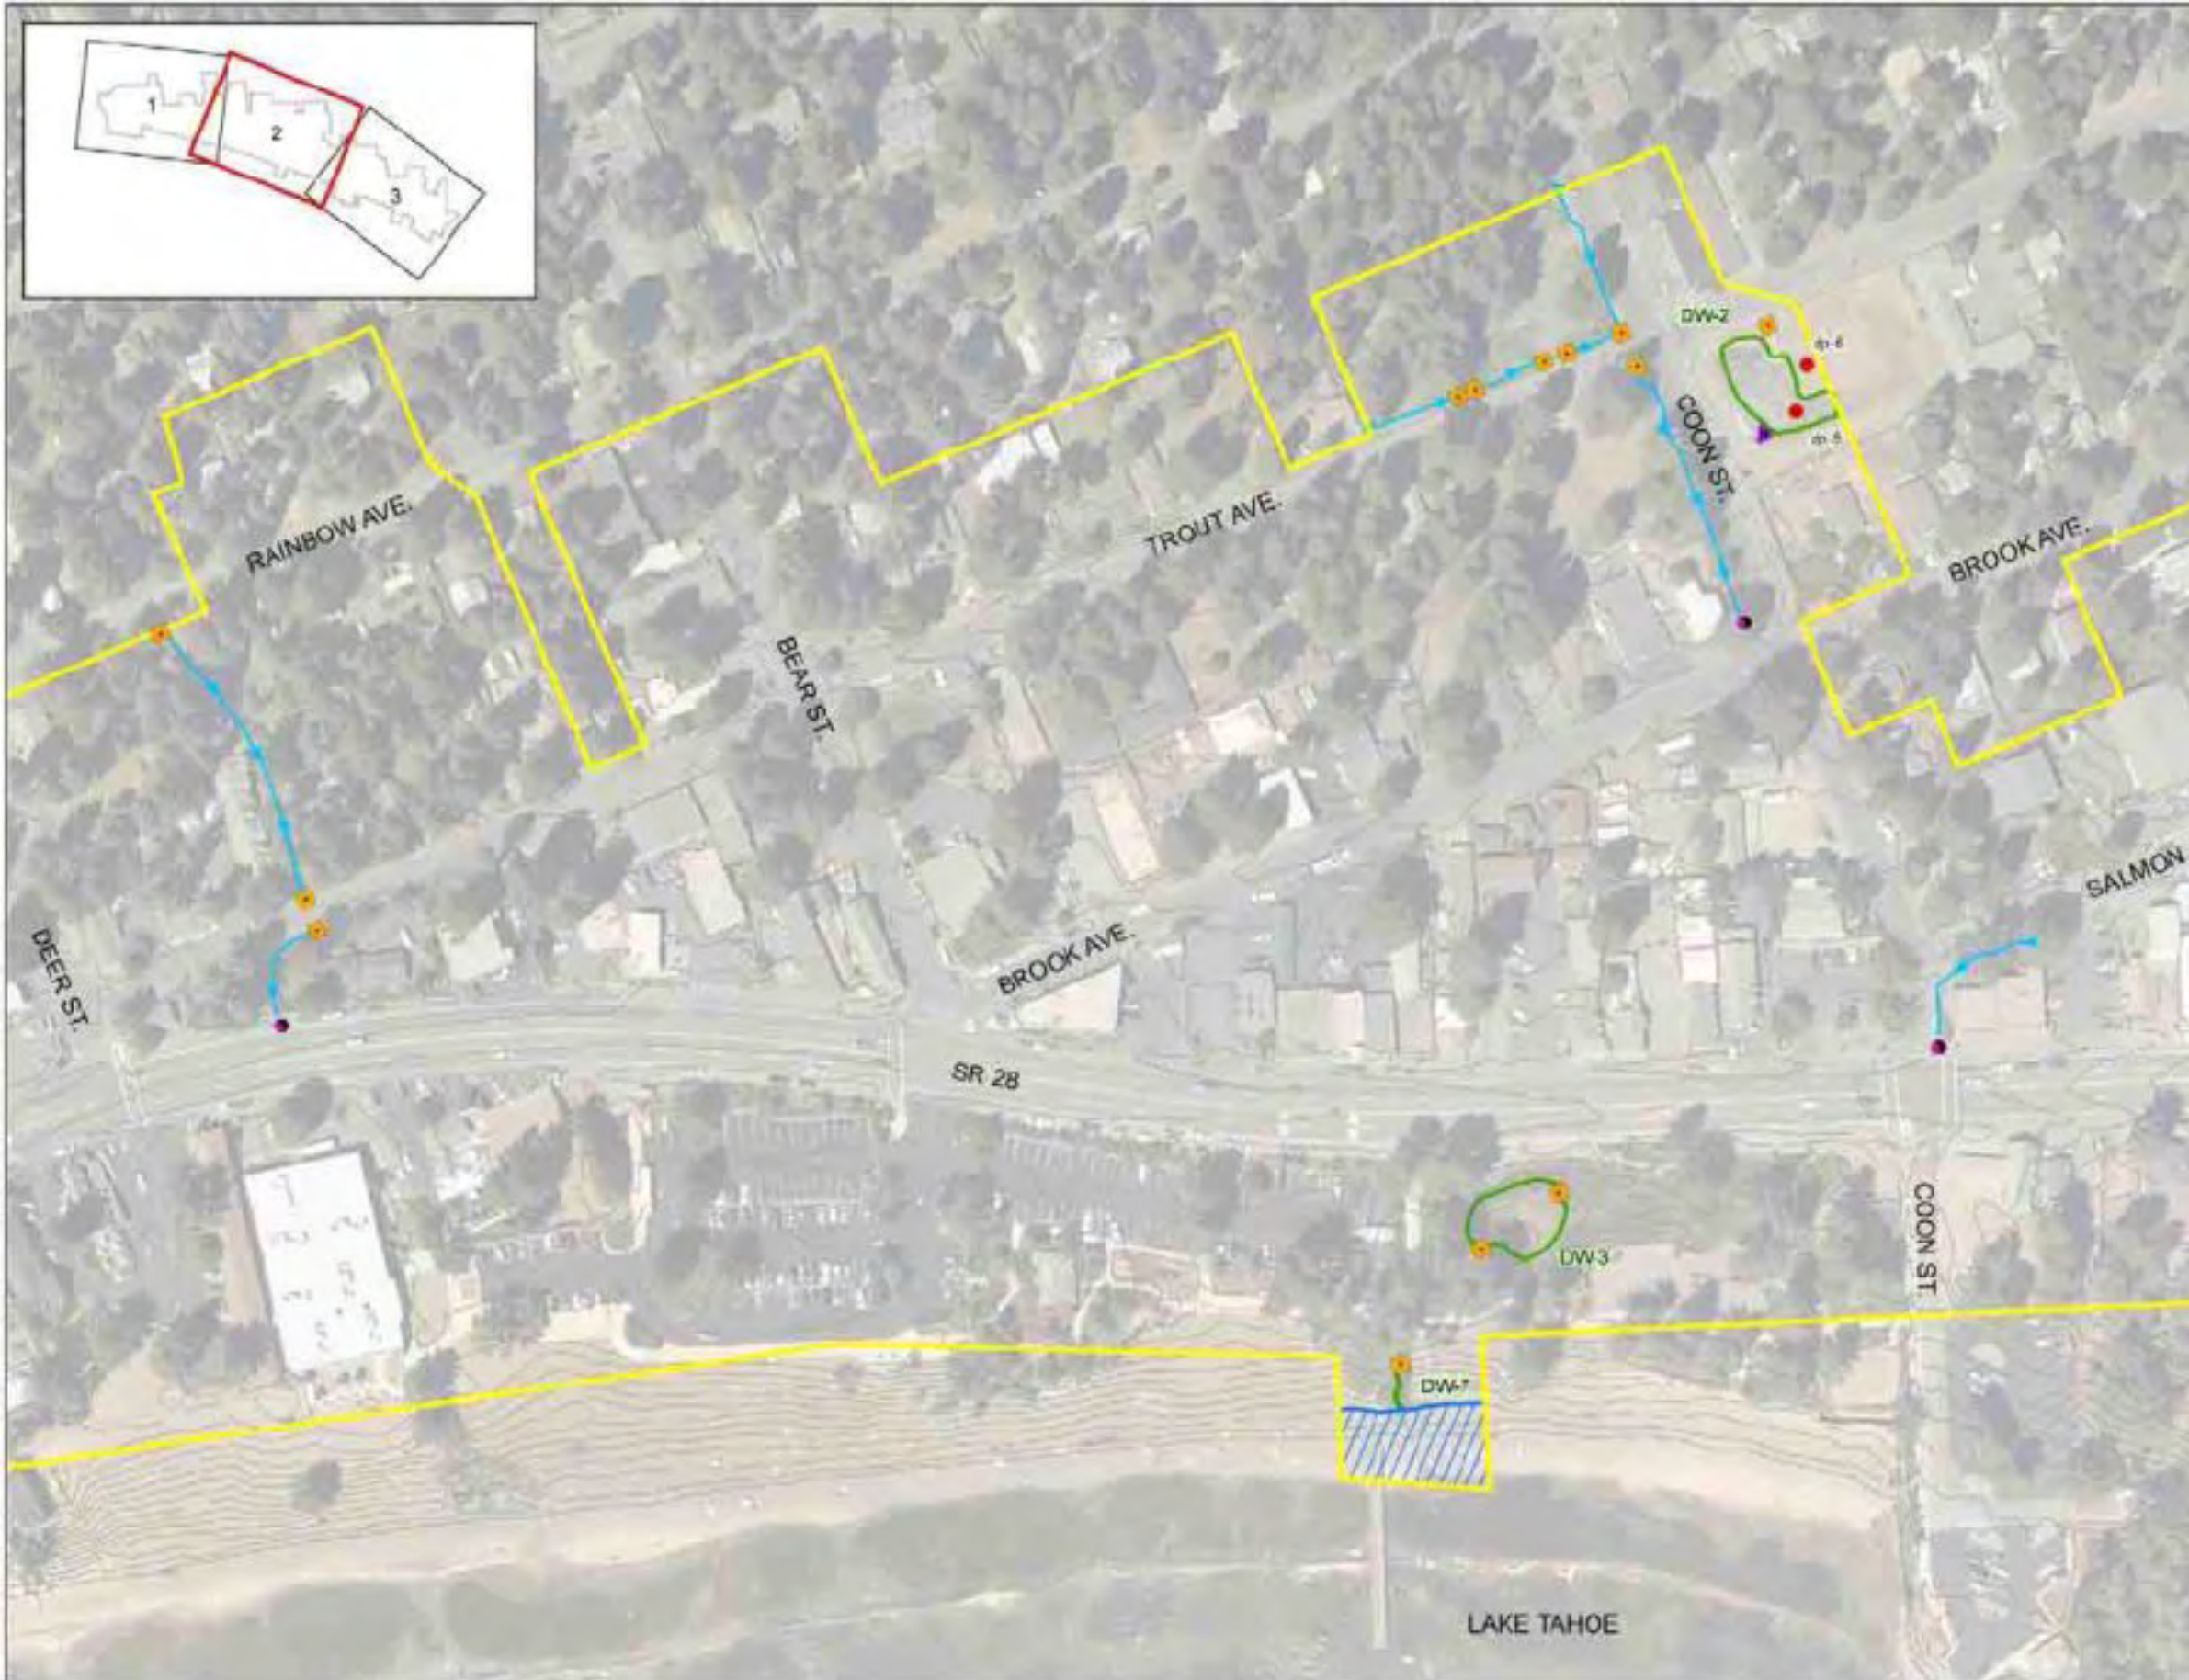
EXHIBIT A

A total of 0.719 acre of waters of the United States, consisting of 0.329 acre of wetlands and 0.390 acre of other waters of the United States, were identified within the boundaries of the delineation study area (Table 3). Intermittent drainage ditches also were observed in the delineation study area but were interpreted to be outside the scope of Corps jurisdiction under Section 404 of the CWA. The general characteristics and interpreted jurisdictional status of each feature mapped within the delineation study area are described below. Representative photographs of the wetlands and other waters observed within the delineation study area are located in Appendix C.

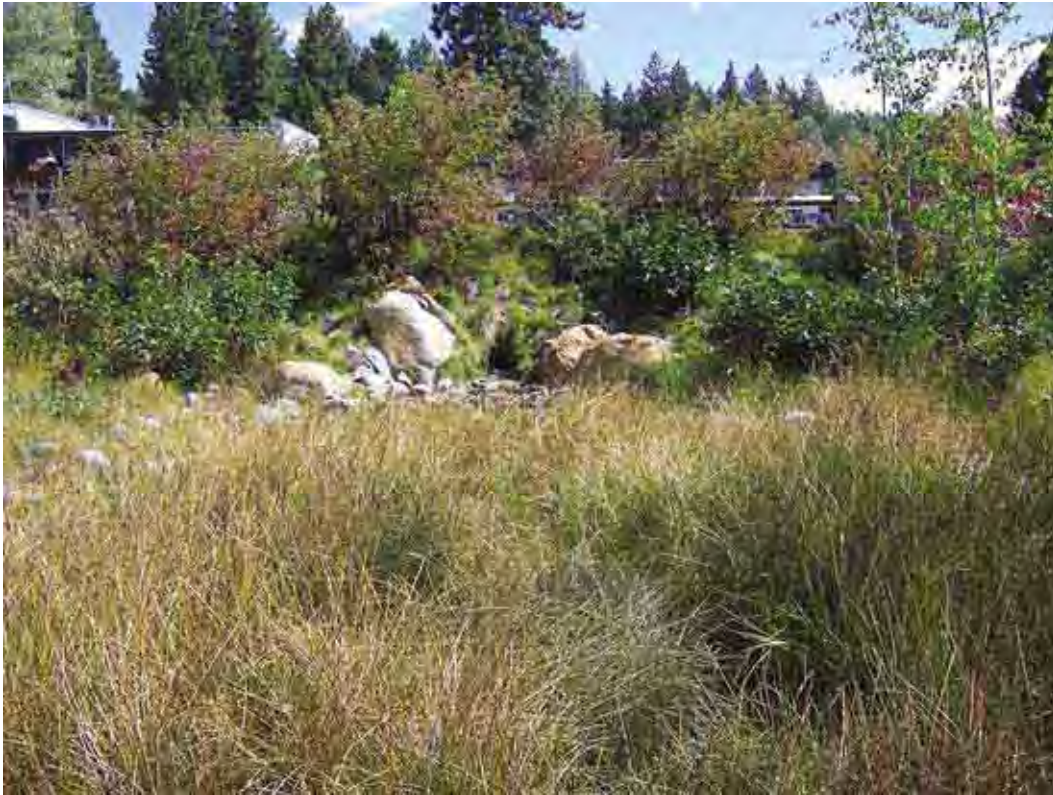
Depressional Wetland #1

A total of seven depressional wetlands were found within the boundaries of the delineation study area (Exhibit A). Five of these wetlands (DW-1 to DW-5) are sediment detention basins that receive most of their hydrologic inputs from drainage ditches and that drain via corrugated metal standpipe drains. The sixth depressional wetland (DW-6) is a roadside depression that retains enough water, primarily in the form of surface runoff, to support hydrophytic vegetation. The seventh depressional wetland (DW-7) is located immediately adjacent to Lake Tahoe and receives water primarily via a culvert at its north end.

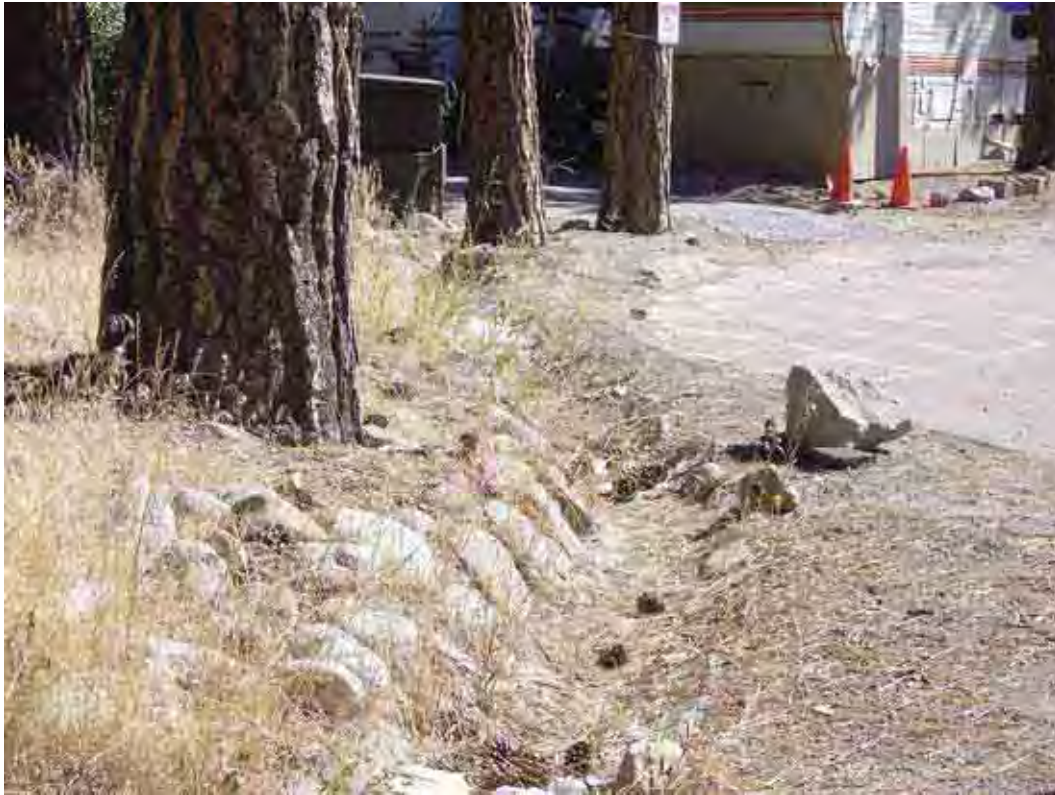
Intermittent Drainage Photo #1

A number of manmade drainage ditches were observed within the boundaries of the delineation study area (Exhibit A). The ditches appear to flow intermittently during periods of snowmelt and intense rainfall and are either unvegetated or are vegetated with upland grasses such as squirreltail, quackgrass, thickspike wheatgrass, and tall oatgrass. Although water conveyed by these drainage ditches appears to discharge into Lake Tahoe via an underground stormwater collection system, they appear to have been excavated in uplands for drainage purposes and do not appear to have replaced any previously existing natural stream features. As such, it is concluded that these intermittent drainage ditches are outside the scope of Corps jurisdiction under Section 404 of the CWA.

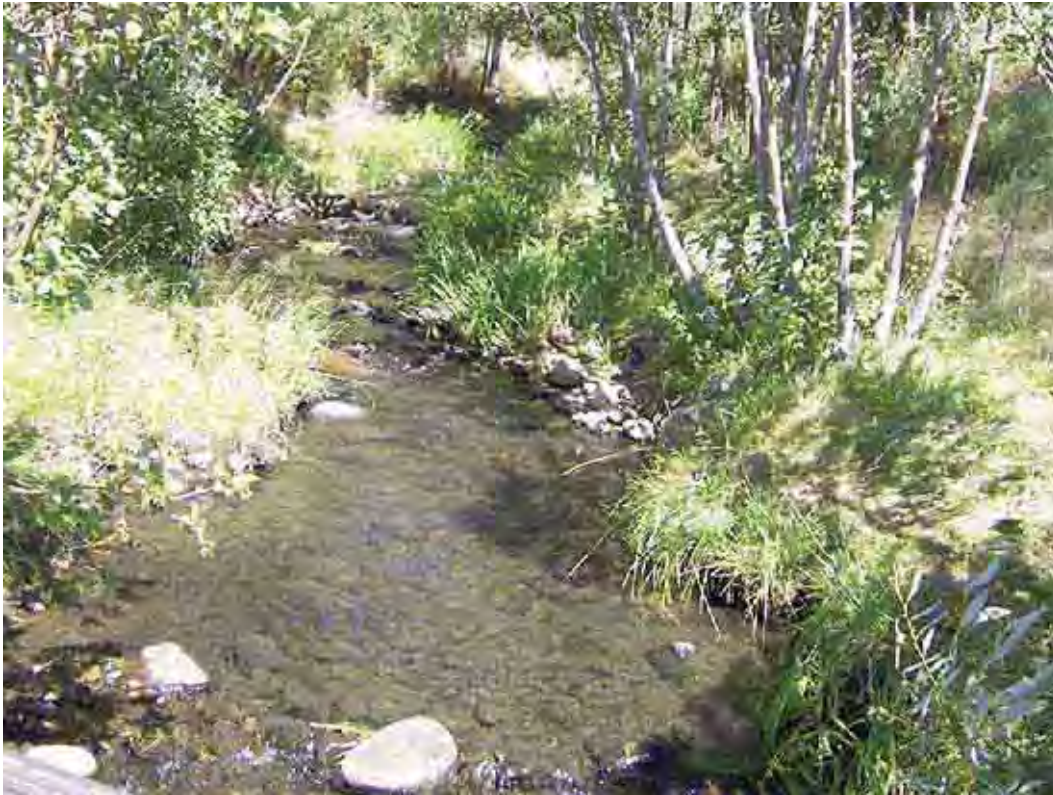
SP-1a Griff Creek

Griff Creek is a perennial stream that begins approximately 1 mile east of Martis Peak and flows south through the western portion of the delineation study area (Exhibit A). The jurisdictional width (i.e., the distance between opposing ordinary high water marks [OHWMs]) of the reach that flows through the delineation study area ranges from 3 to 30 feet (Exhibit A). The OHWM was identified based on the geomorphic characteristics of the stream channel (namely shelving). The reach supports a narrow band of riparian trees and shrubs that are primarily located above the OHWM.
